Case Study: Wet Sealing Metal to Glass Joints at Main St. Tower- Norfolk, VA

Completed: February 2013

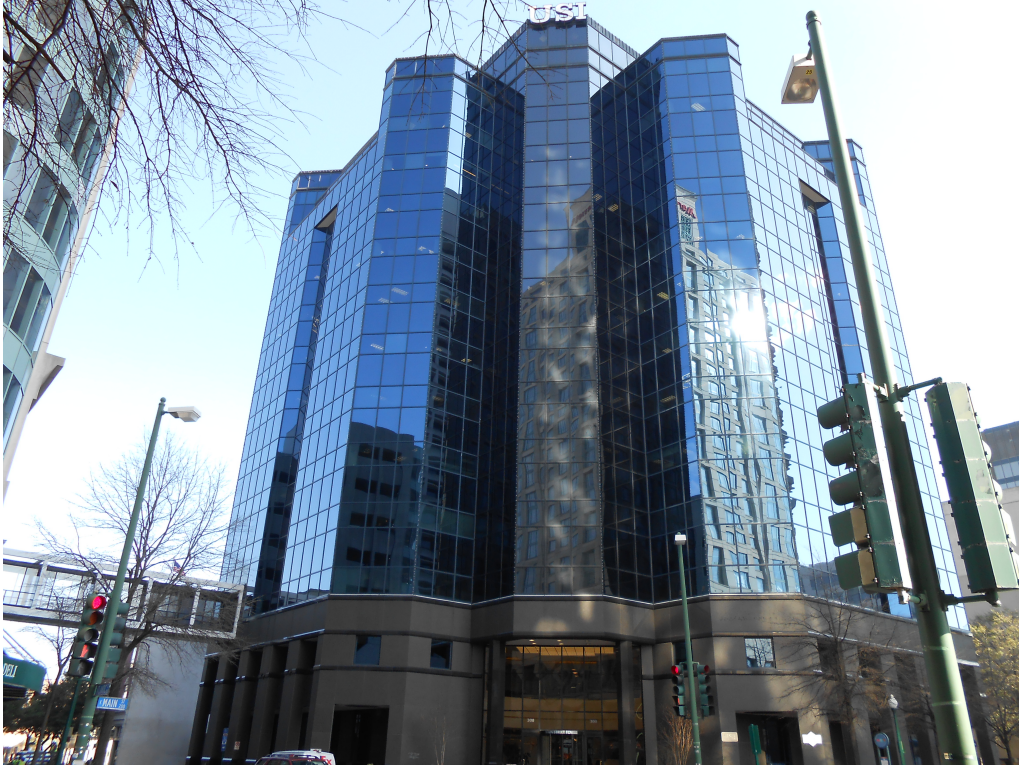
To correct numerous water infiltration problems in a 20+ year old, 14 story glass & metal curtain structure. Strict budget constraints, limited access and multi-faceted elevations in a busy downtown environment where repairs cannot impede the daily business operations.

To ease the capital expenditure, a 5-year timeline was established to perform the repairs in phases while meeting the need to correct critical areas and tenant concerns. Custom made roof top davits were sourced to access portions of the building previously un-accessible do to budget cuts during construction. Custom silicone boots were made to correct design flaws that would have required partial system replacement. New high performance joint sealants added protection where old building materials had failed. The resulting remediation allowed the building owner to make the needed repairs, preventing future damage while staying within budgeted timelines and costs.
